# JETMASTER (VIC) PTY LTD

# THERMAL CLEARANCE TESTING OF THE VISIONLINE TAURUS FREE-STANDING APPLIANCE

Report Number: ASFT20014-1 Issue date: 28 May 2020

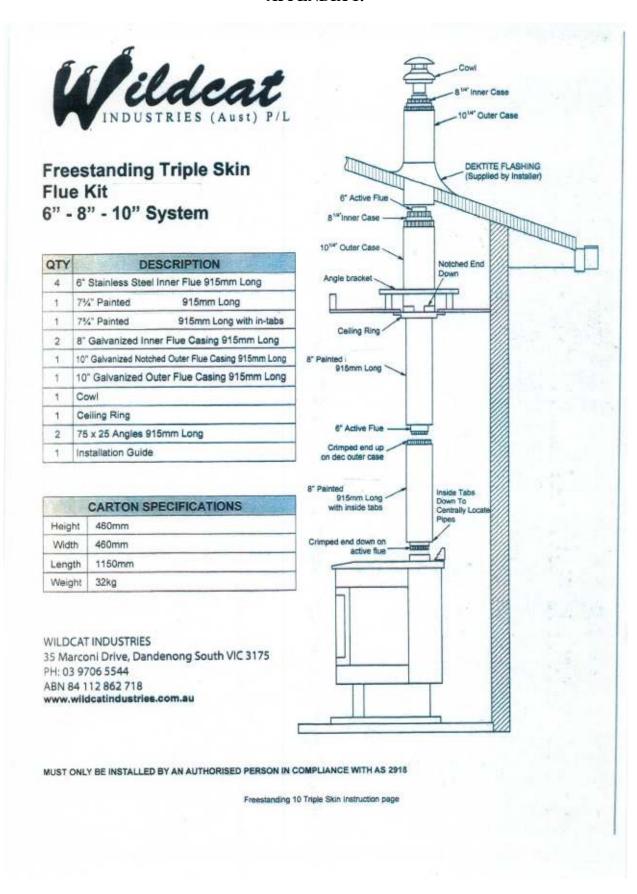
#### **APPENDIX 1:**

The flue system used during testing was a Wildcat 6" triple flue kit with 8" solid casing was supplied by Wildcat Industries Pty Ltd. This flue system has not been tested to joint AS/NZS 2918:2018, Appendix F. The flue height was  $4.6 \pm 0.1$ m from the floor protector. Appendix 1 shows details of the flue system.
